# HAWKEYE

## Addendum Page

**Client:** Jane Smith  
**Address:** ABC Street, Concord, MA 01742

**Date:** 10-29-10  
**Inspector:** Bryan Wilcox

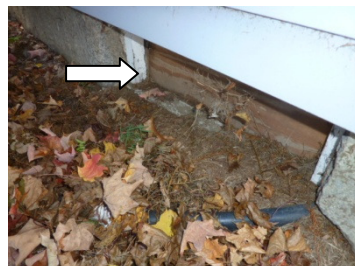
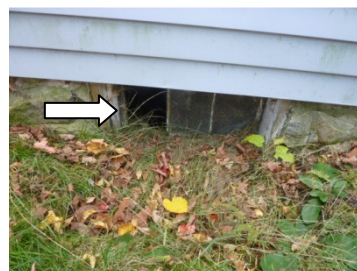
- 5) **Basement Windows:** The basement windows have been partially boarded up. The ground is partially covering the window openings. There is a broken/missing pane of glass at the window beneath the kitchen area. Outside air is flowing freely into the crawlspace beneath this area. Recommend repairs to all basement windows in order to seal the basement and crawlspace areas.

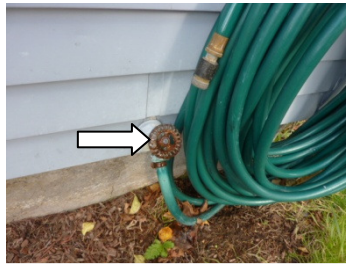
- 6) **Exterior Hose Faucet:** The hose spigot on the driveway side of the home was dripping and leaking. Recommend repairs to stop the leaking.

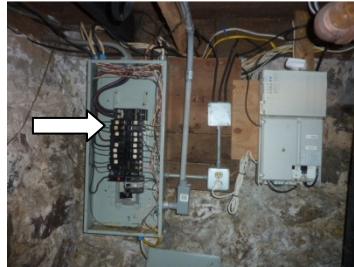
- 7) **Electric Cable to the Barn:** The cable to the barn is 10ft off the ground. It should be 12ft high as it goes over the driveway.
- 8) **Water Main:** The water main appears to be galvanized pipe. Galvanized piping is known to corrode from inside the pipe and restrict water flow. Functional flow of multiple fixtures was seen on the 2<sup>nd</sup> floor bath and no problem was seen. Monitor as this situation typically get worse with time. The pipe will eventually need to be replaced.
- 9) **Electric Panel:** The cover to the electric panel was lying on the ground at the time of the inspection. This constitutes a safety hazard and this cover should be replaced immediately for safety enhancement.

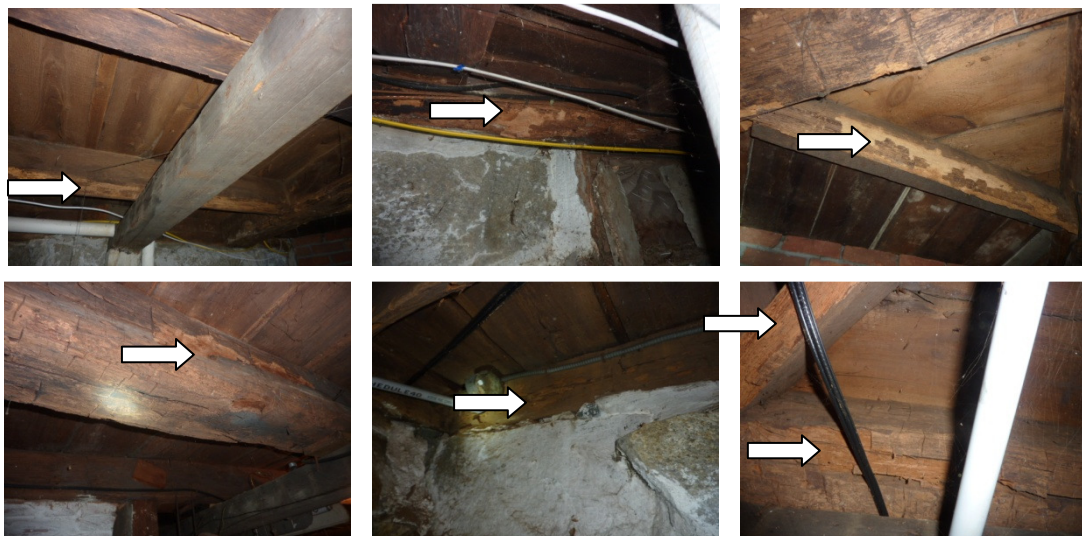
- 10) **Basement Wood Structure:** There is visible wood destroying insect damage (WDI) along most of the sills in the basement area. Most of the beams and joists also have visible damage. The damage appears to have been caused by powder post beetles, although minor termite activity was also noted. Recommend having the wood structure treated for WDI. Note: The damage to the wood appears to be primarily on the surface, but only a structural engineer can determine if the structure has become structurally deficient. At minimum, some areas of the sill will probably require replacement. The wood columns are not properly footed but appear to be adequate.

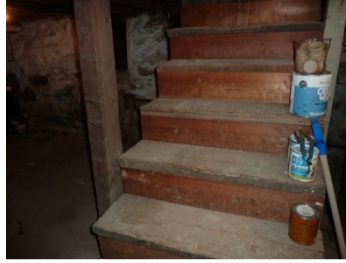
- 11) **Basement Stairs:** The basement stairs are considered a safety hazard due to the lack of railings and balusters. Recommend repairs for safety enhancement.

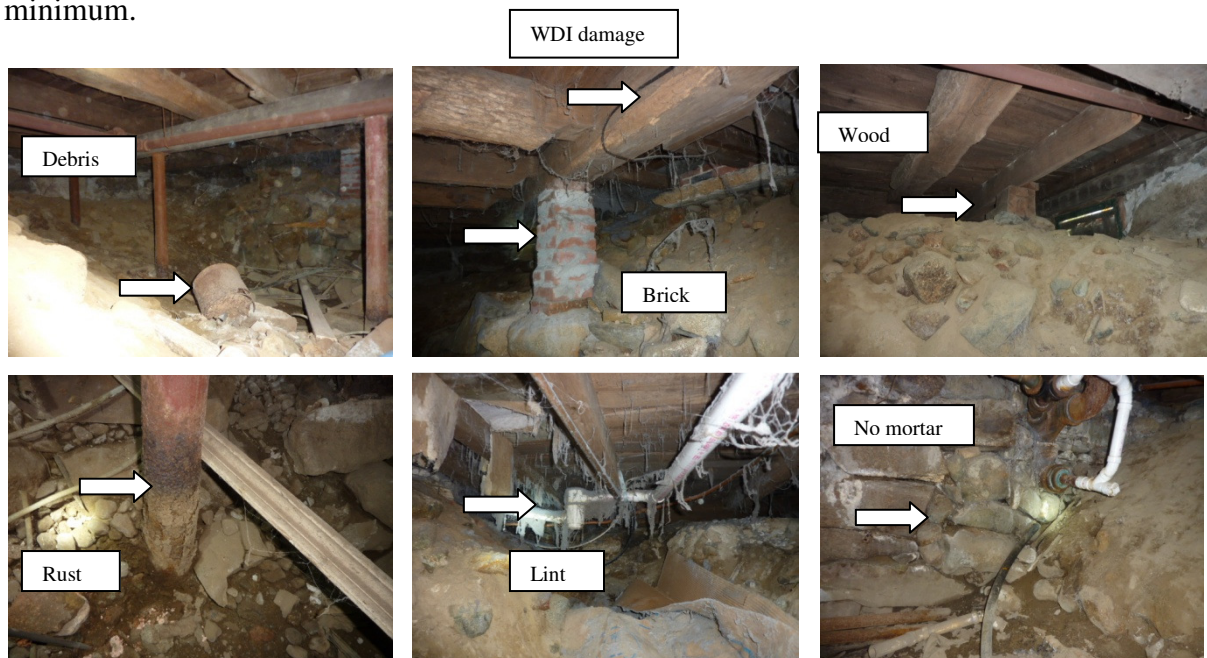
- 13) **Crawlspace:** The crawlspace has a lot of construction debris. Some of the stone foundation does not have mortar. The steel support columns are hollow and have visible rust and deterioration. There were a couple of improper/inadequate supports (bricks and wood) to the floor joist system. There is a tremendous amount of lint in the crawlspace. The dryer vent appears to be discharging into the crawlspace. The window to this area is missing and outside air is freely entering the crawlspace. Recommend mortaring all areas of the stone foundation. Recommend scraping/painting steel support columns. Recommend removal of all construction debris and unnecessary stones. Recommend sealing the window to prevent potential freezing of the pipes in the winter. Recommend installing a vapor barrier on the floor to seal area from soil gas (water vapor). Recommend relocating the dryer vent to an exterior location. Note: Recommend running a properly sized dehumidifier in the area to keep moisture levels to a minimum.

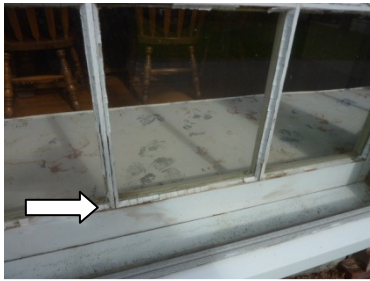
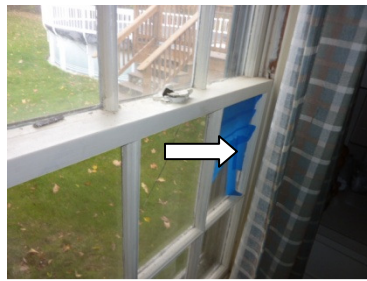
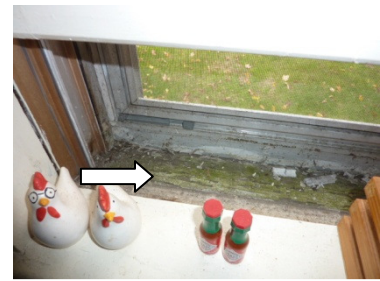
- 14) **Windows:** There are two different window types on the property. There are newer, double hung, double pane, vinyl replacement windows. These all were serviceable. The older wooden windows all have significant chipping/flaking of paint and glazing. Many of the sash cords were broken and a few windows had broken glass. Recommend repairs to all old wooden windows to restore proper function and condition.

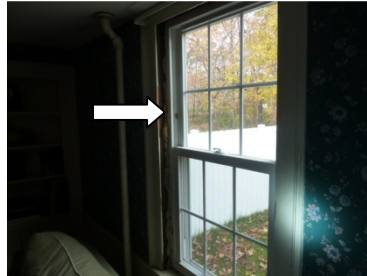
- 15) **1<sup>st</sup> Floor Office Window:** There is not finish detail and trim around the interior of this window.
