## Confidential Inspection Report

**Somewhere  
Where, MA 00000**

Inspection address: 7 This Street, Somewhere, MA

I have personally inspected the home located at 7 This Street, Somewhere, MA. The purpose of the inspection is to determine the adequacy of the major structural and mechanical systems.

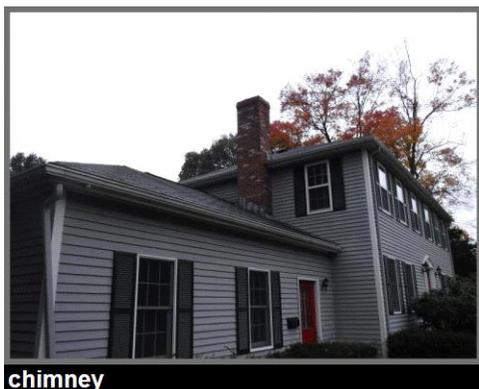
*Location:* Left, *How Inspected:* Binoculars. The condition of the flue liners or determining whether they are present is not part of this inspection. Consider adding a rain cap.

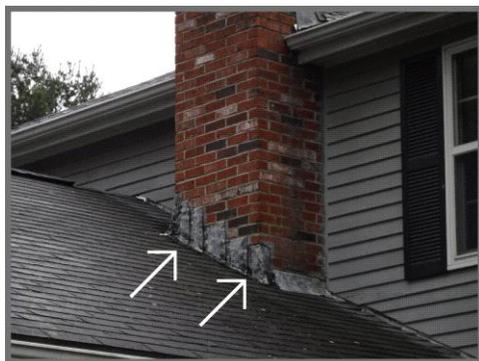
**example-flashing not integrated**

- Chimney flashing is not mechanically integrated with the shingles.

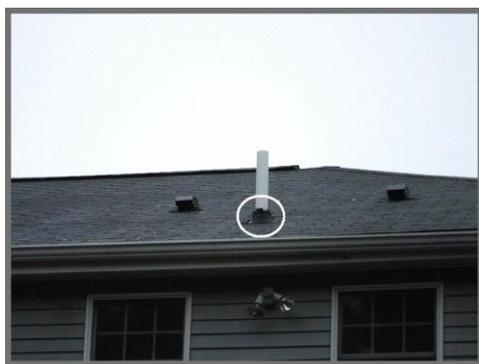
**bathroom vents/vent stack boot damage**

- Boot is damaged.

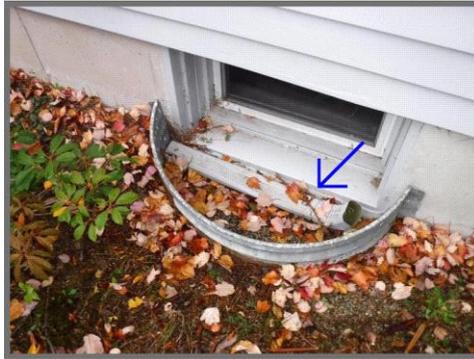
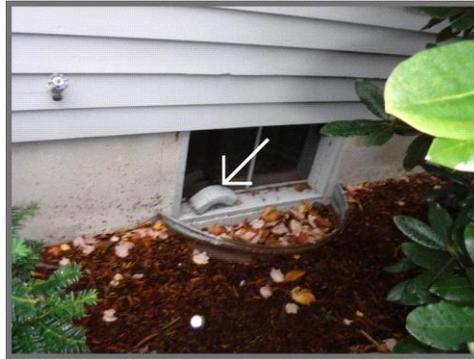
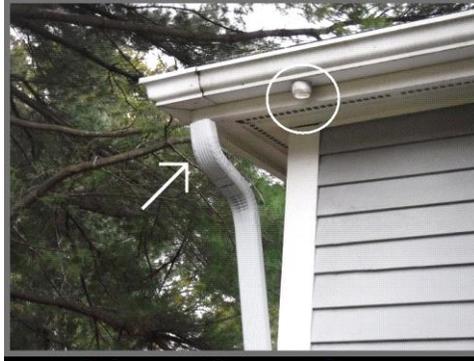
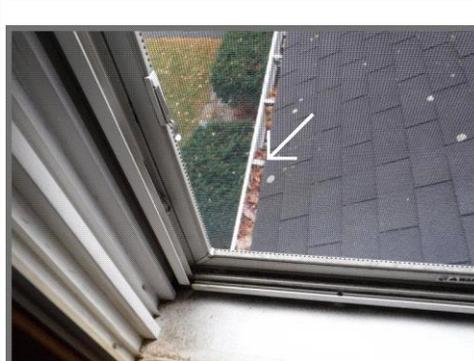
*Type:* Aluminum gutters. Gutter system exhibits improperly secured downspout at the front left. Disconnected downspouts present. Gutter components are scattered near the foundation. Gutters need cleaning. Gutters and subsurface drains are not water tested for size, leakage or blockage. Regular maintenance of drainage systems is required to avoid water problems at the roof and foundation.

example-downspout component

abandoned downspout elbow

example-improperly secured downspout

gutters need cleaning

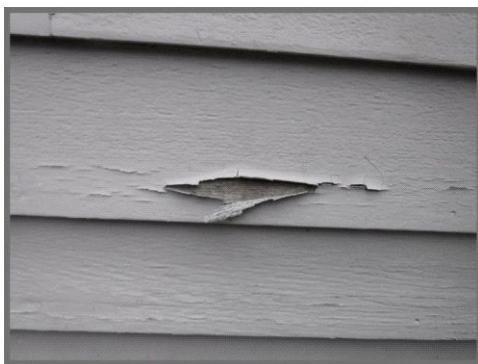
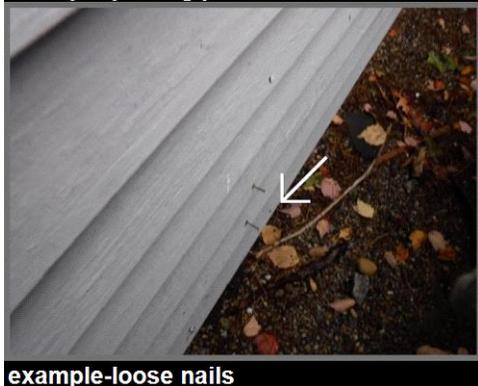
This is a visual inspection only. Some paint peeling. Some loose nails. The inspector cannot make judgments regarding the conditions behind exterior covering of walls. Every reasonable effort is made to look for indications of pest or moisture damage to walls and other structural systems. However, it is beyond the scope of this inspection to make judgments about concealed conditions in these areas. If it is suspected that concealed damage may be possible, then a licensed contractor should make a more detailed and exhaustive evaluation of the areas that are suspected of hidden damage. Repair or replacement is needed. Suggest further evaluation by a contractor to determine scope of work and costs. Determining the presence of asbestos or hazardous materials is beyond the scope of this inspection, Siding should be about 6" from soil whenever possible. Peeling paint, some siding is not secure.

**example-peeling paint**

**example-loose nails**

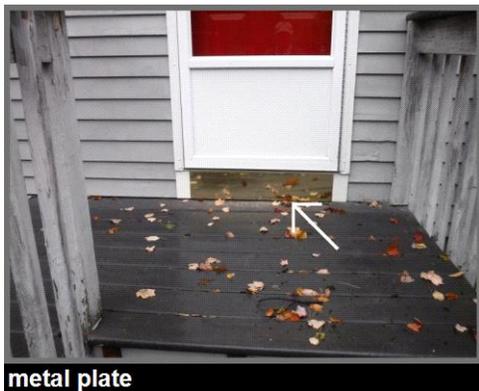
Note metal plate at the threshold. May be covering past damage. Not accessible. Key bolt locks may be a safety issue for young children.

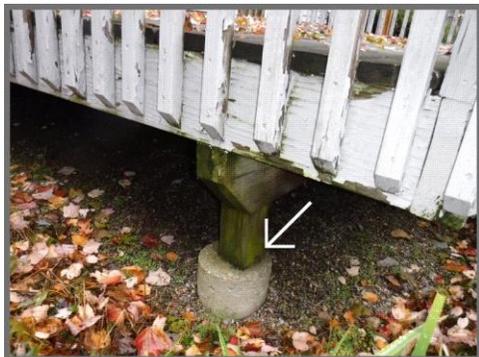
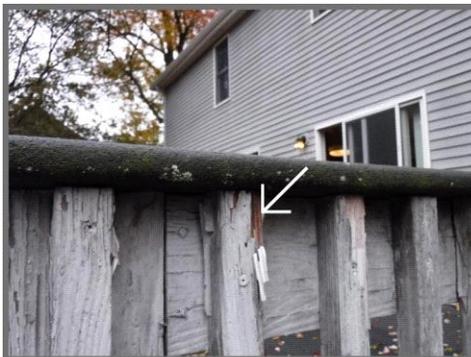
Not fully accessible. Some worn paint. Some balusters exhibit some dryrot. Deck is bolted to the home. Not built to current requirements but the integrity of the deck is acceptable.

no metal standoff

example-minor rot

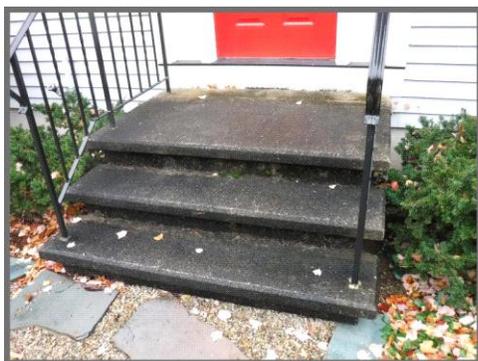
front stairs

*Materials:* Concrete. Inadequate footing.

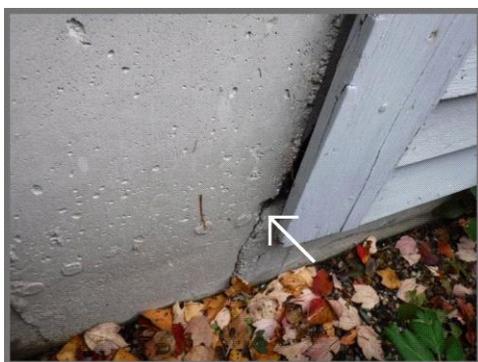
- Concrete. Note gap between main foundation and foundation of office.

settling crack/gap

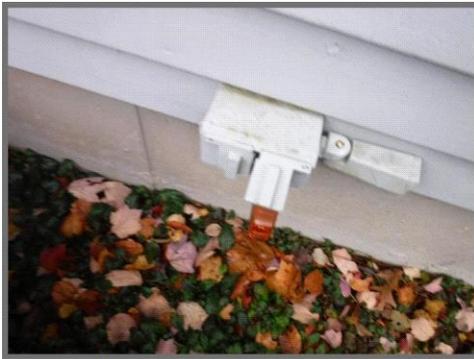
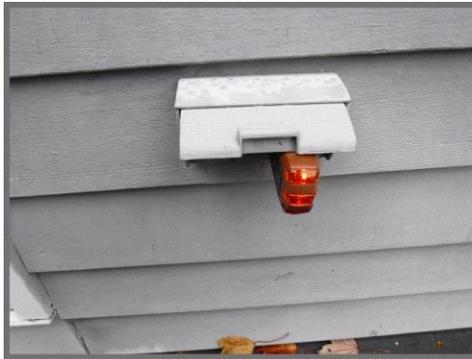
- Rear GFCI outlet failed to trip. Front outlet is not GFCI protected. One side of the front outlet exhibits loose wiring. This is a **safety issue**.

front outlet-failed to trip

rear GFCI outlet-failed to trip

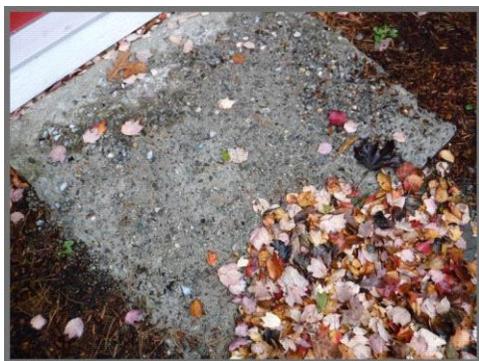
*Type:* Flagstone. Concrete. Note deterioration at front side door... Trim bushes away from the walk.

**deterioration-front side entry**

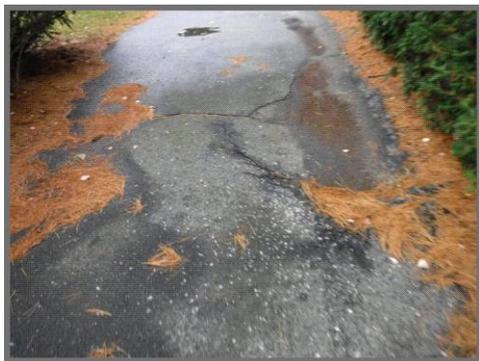
*Type:* Asphalt, Cracked and heaving driveway present. Small fissures and holes in an asphalt surface can quickly expand into larger gaps and potholes if snow and ice get into them. Clean out the fissures and gaps. Once dry, use a caulk gun and inject a sealant.

example of heaving

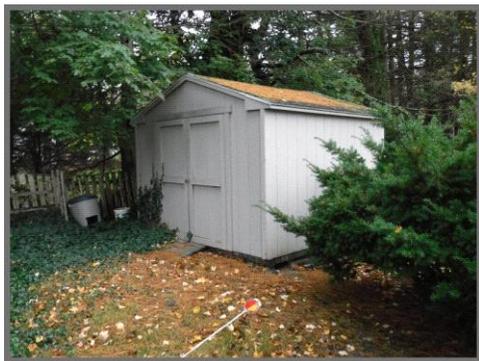
shed

The Shed is not part of this inspection. Footings appear to be wood. Keep soil away from the siding to prevent further dryrot.

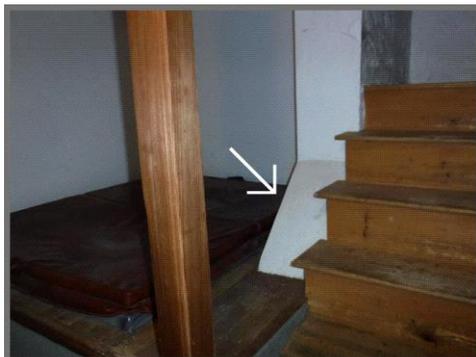
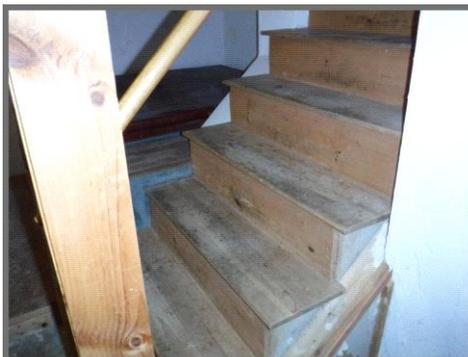
Missing balusters. This is a **safety issue**.

example-missing balusters

example-missing balustrades

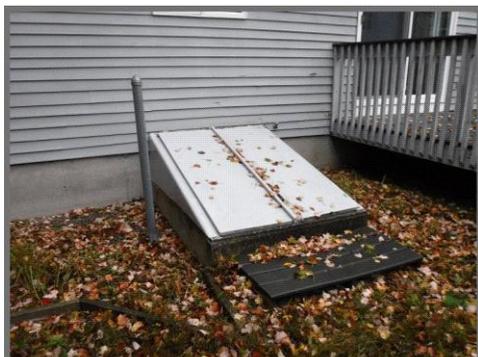
**bulkhead**

*Type: Metal Bulkhead. Some rust.*

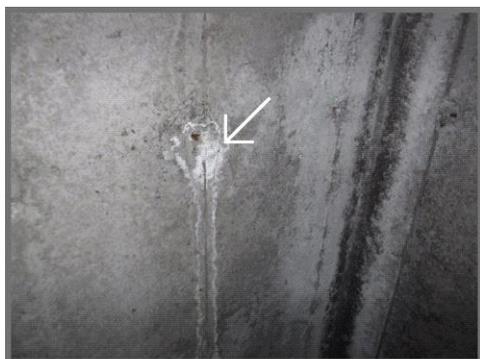
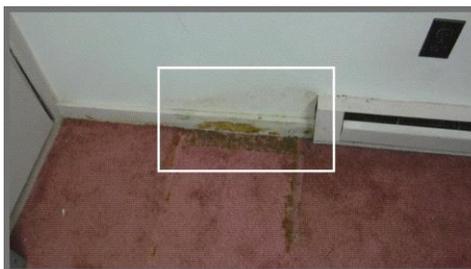
**example-tie rod/past water staining**

**water staining**

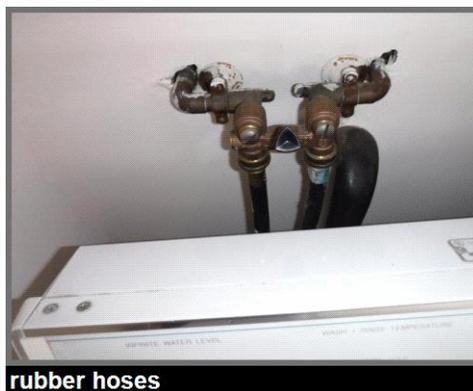
Rubber hoses. Suggest upgrade to stainless steel (no-burst) washer feeds.

rubber hoses

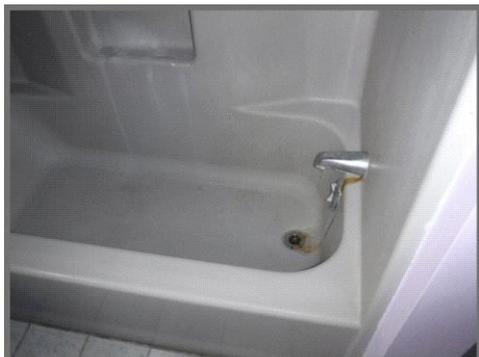
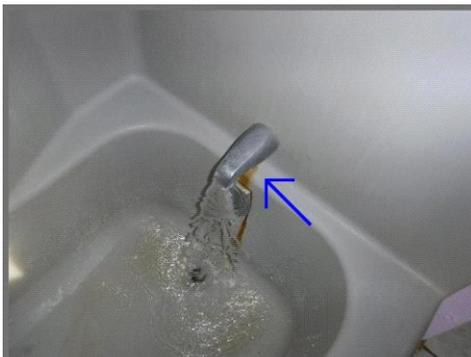
Leak at the faucet. Note staining.

**past leaking/stain**

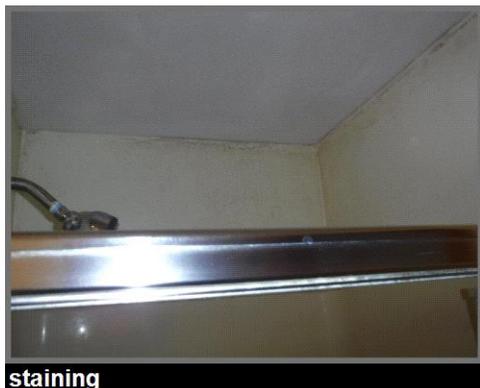
Some black "mold-like" staining where shower wall meets the ceiling.

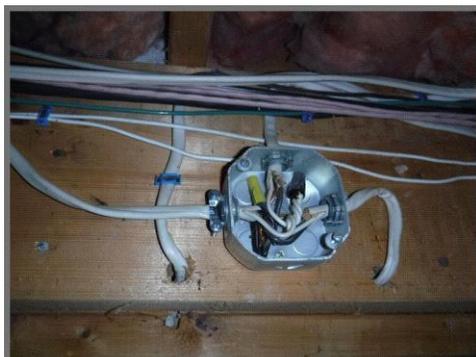
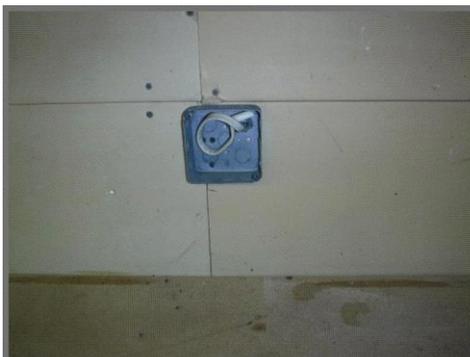
*Condition:*  
     Install junction box covers where missing - basement.

**example-missing cover**

**example- incomplete wiring**

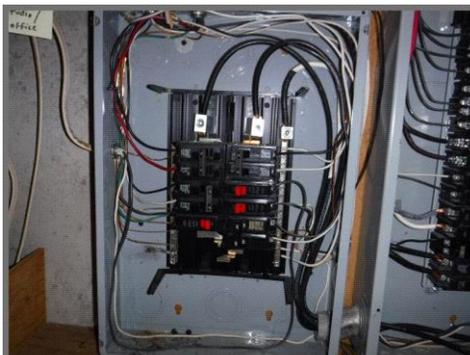
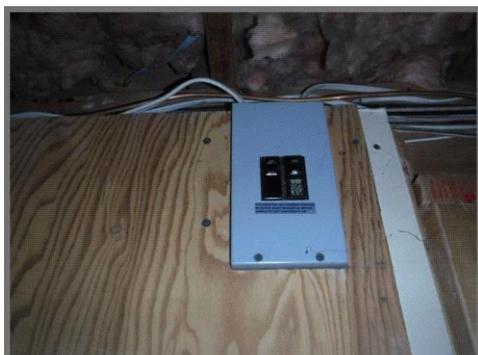
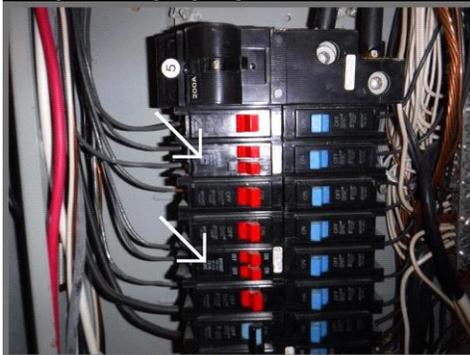
*Condition:*  
     There schematic does indicate that the main box is designed for split or "mini" breakers. However, some mini breakers are not in the proper location. A licensed electrician should inspect and/or repair this condition. This is a **safety issue**.

sub panel-improperly wired

breakers were not identified

example-mini breakers-improper location

Condition:  
     Grounds mixed with neutrals. A licensed electrician should repair this condition. This is a **safety issue.**

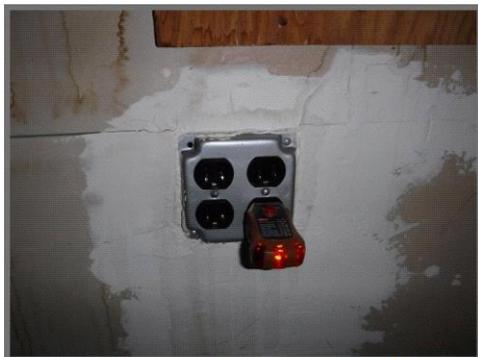
- Outlets in the unfinished basement are not GFCI protected. A **safety issue**. When existing receptacles are replaced in locations where GFCI protection is currently required, the replacement receptacles must be GFCI protected. This includes the replacement of receptacles in bathrooms, garages, outdoors, crawlspaces, unfinished basements, kitchen countertops, rooftops or within 6 feet of laundry, utility, and wet bar sinks.

example-basement outlet-not GFCI protected

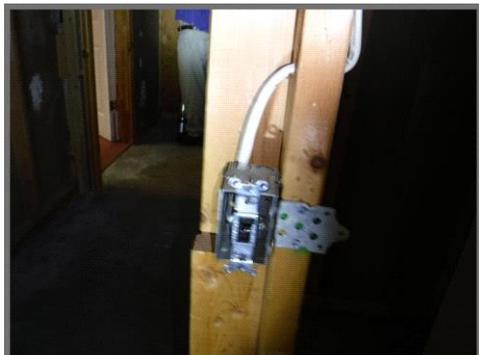
- Some covers are missing. This is a **safety issue**. Only a representative number of switches, outlets and fixtures which are readily accessible, were tested.

**example-missing cover**

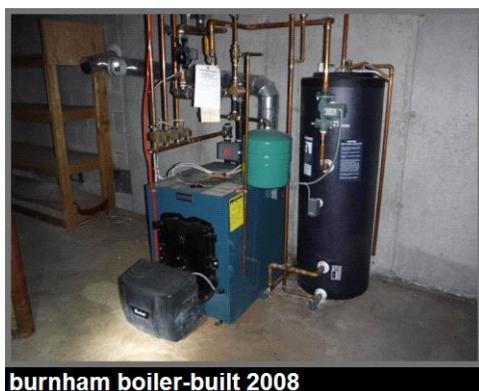
Burnham brand. Built 11/2008. The average life expectancy is estimated at between 20-35 years. Some boilers last longer and some fail prematurely. Regular maintenance is needed to keep the boiler operating for many years. Any boiler that is 20 years or older should be closely monitored and serviced. Budget for a replacement if the boiler is over 30 years old. The report indicates the condition of the heating and/or cooling units on the day of the inspection, without regard to life expectancy. We suggest you obtain a major service policy or warranty, which should include annual servicing, adjustment, efficiency testing and emergency service.

**burnham boiler-built 2008**

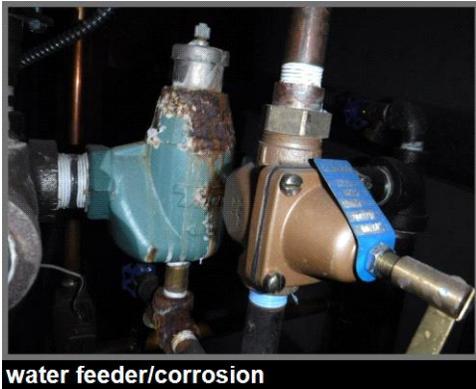
- Corrosion. Monitor for leaks.

**water feeder/corrosion**

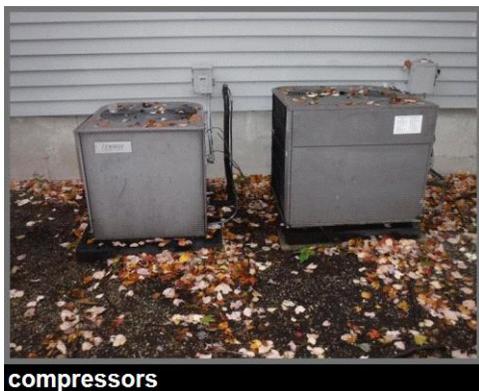
**compressors**

- S/N of one compressor is 5189C0083 indicating that both air conditioning systems were built in March, 1989. The air conditioning systems are fully depreciated.

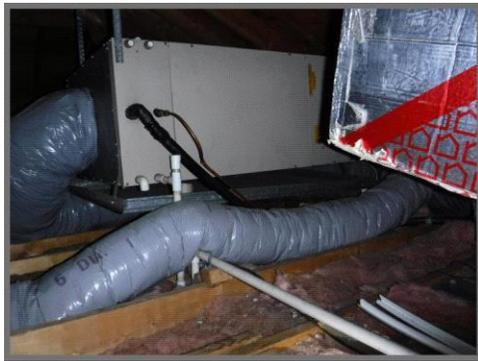
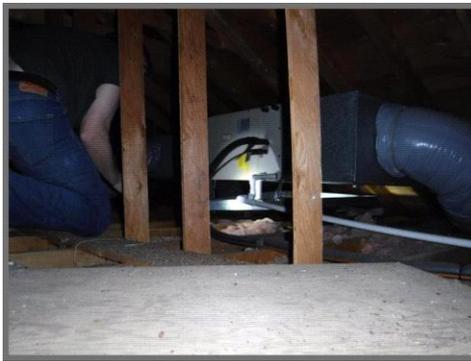
- Unit at the main residence has no float switch; unit over the office space has a float switch. Overflow pan is missing. Consider installing a float switch to prevent ceiling damage. Fully depreciated.

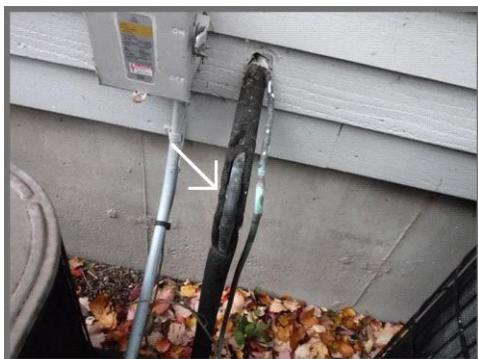
- Missing insulation. Tests are not conducted on coolant systems. Therefore, no representation is made regarding coolant charge or line integrity.

example-damaged insulation

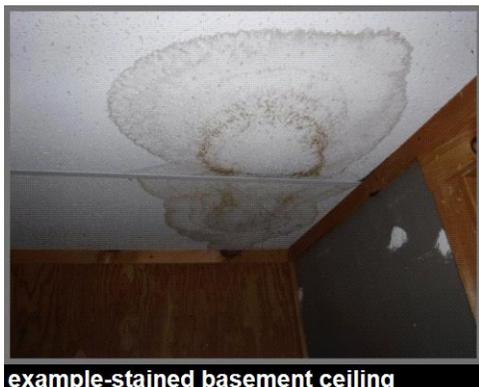
Past water staining at several locations. Not active. Staining noted on the basement ceiling, office ceiling and bedroom ceiling.

example-stained basement ceiling

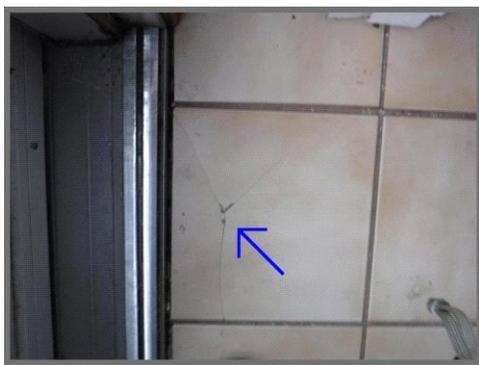
Cracked tile near the rear entry, some rugs are improperly secured.

**example-cracked tile/rear entry**

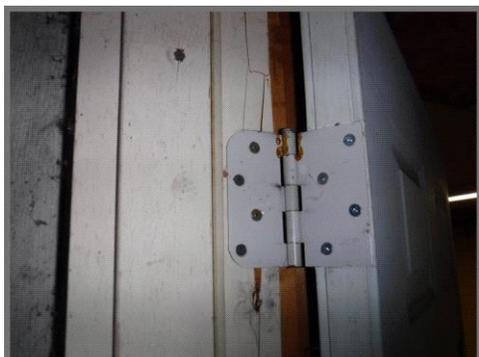
Some door frame damage, one 2nd floor failed to latch.

**example-damaged door frame**

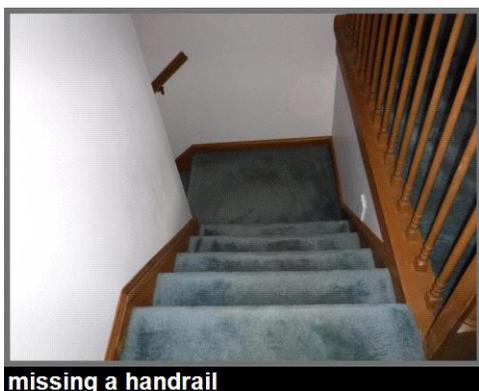
- Upper portion is missing a handrail.

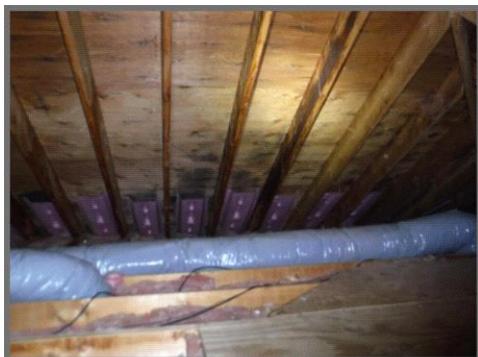
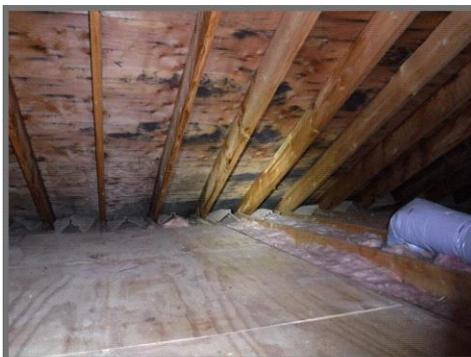
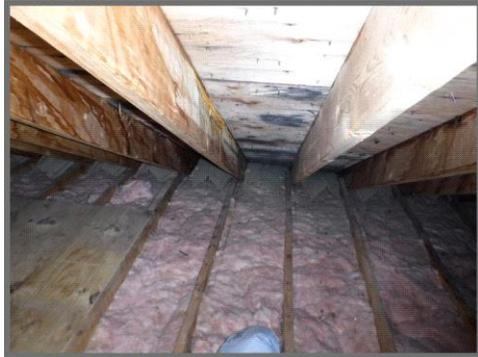
*Type:* Plywood, Observed black "mold-like" stained roof backings, indicating excessive moisture and insufficient ventilation.

example-black "mold-like" staining

black "mold-like" staining

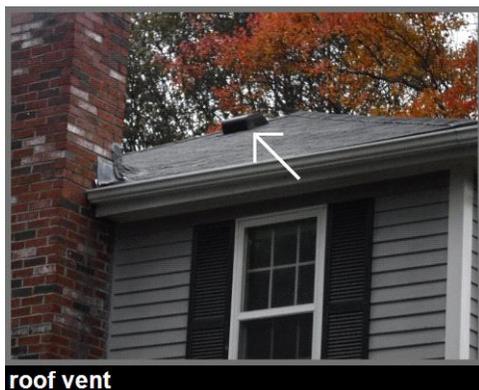
*Type: Ridge Vent, Soffit Vents, Roof Vent. Many soffit channels are collapsed/damaged. Lack of adequate ventilation.*
